Case Study of the Performance of Prestressed Concrete Buildings During the 1985 Mexico Earthquake

The overall effects of the 1985 Mexico earthquake on buildings are summarized, with specific consideration of the performance of prestressed concrete buildings. Then, for five typical prestressed concrete buildings, results of analyses of the dynamic response, with due consideration of the soil-structure interaction, are presented. In general, the computed response of the buildings under the effect of a ground motion simulating the 1985 earthquake, corresponded reasonably well with their observed performance. Nevertheless, in some cases the analyses indicated that the buildings should have experienced a greater nonlinear behavior than the ones perceived from their level of damage. Some reasons for these differences are discussed. Recommendations on earthquake-resistant design of prestressed concrete buildings are given. The importance of providing lateral stiffness by shear walls or bracing, and of achieving ductility and continuity through mild steel reinforcement, is emphasized.

ASSESSMENT OF EARTHQUAKE DAMAGE

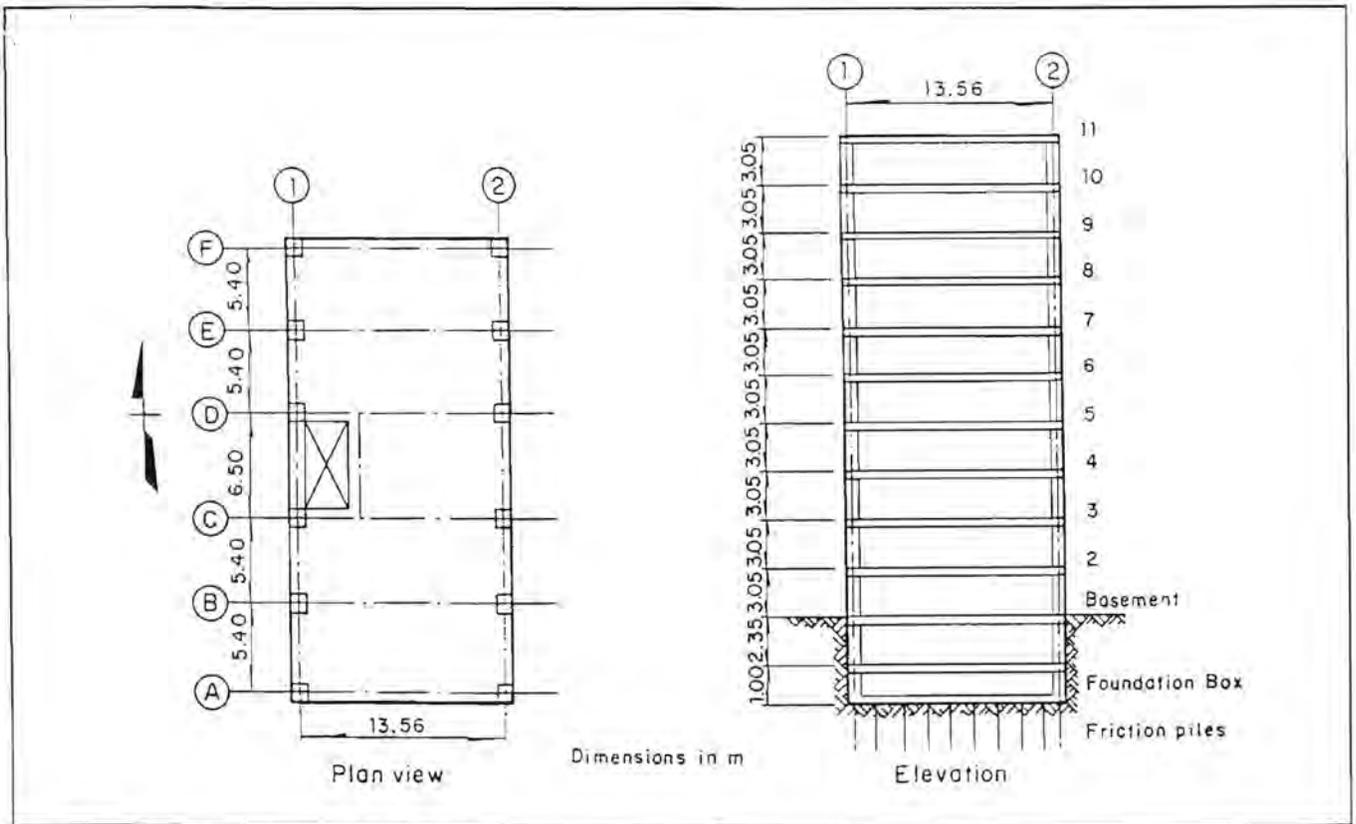
Fig. 7. Plan and elevation of the QRO Building.

An inspection of the building after the earthquake revealed extensive cracking in the masonry walls around the elevator shaft and distortion and falling of some ceiling panels. No

cracks were found in the main structural members. The building showed a significant tilting in its short direction (corresponding to about 2 percent of the building height).

It cannot be excluded that some tilting already existed before the earthquake, although it had not been noticed by the tenants. It is assumed that overturning moments, caused by the lateral forces, produced compressive forces on the piles in excess of those that could be transmitted through friction to the soil. Settlement and non-symmetrical vibration of the building were then generated.

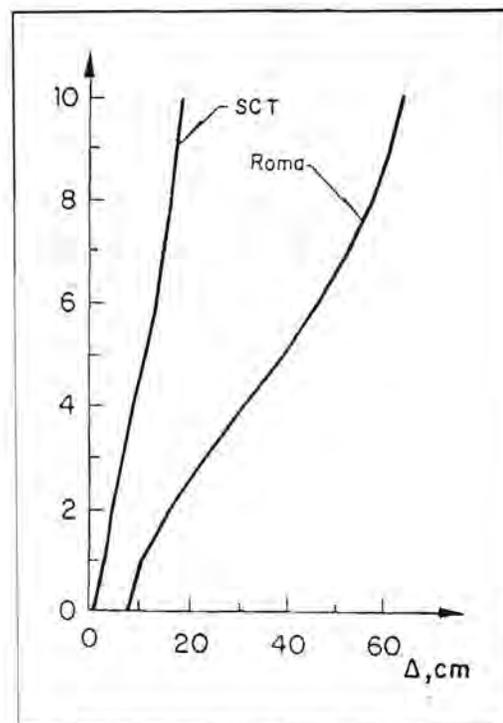
Fig. 10. Maximum lateral displacements using linear analysis for the QRO Building.

cent for the ROMA record. Lateral displacements of this order of magnitude should have caused significant structural damage.

From the analysis, it is apparent that the observed response did not correspond to that predicted, since the lack of structural damage indicates that the structure remained linearly elastic. It cannot be excluded that some cracks formed during the vibration and then closed, leaving no visible evidence; nevertheless, strains in the steel and concrete could not reach the values indicated by the analysis.

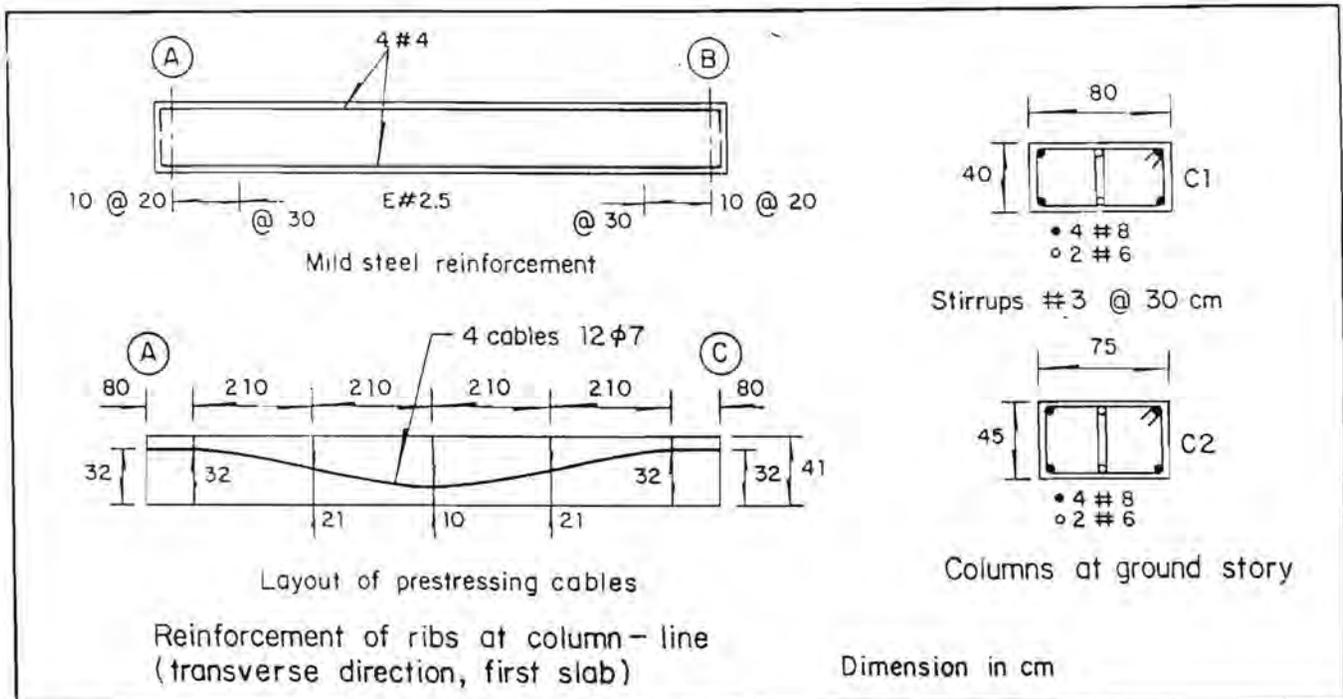
Fig. 14. Typical reinforcing details of structural members of the TAM Building.

damage was found when the building was inspected. Tenants mentioned that large lateral displacements were felt and that light non-structural damage was caused by the earthquake.

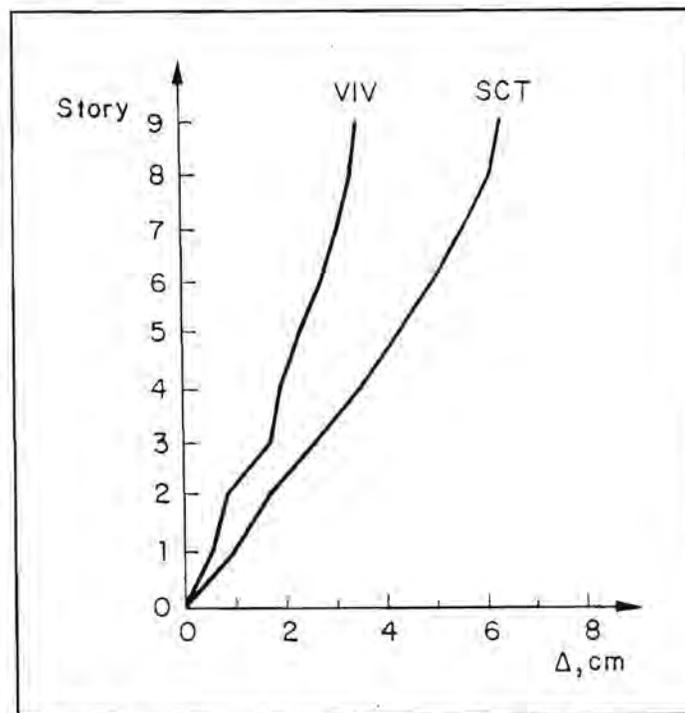
Fig. 15. Maximum lateral-displacements in the TAM Building.

Since the building was located at the boundary of the lake zone, it was analyzed both for the effect of the SCT and VIV ground motions. Maximum lateral displacements are shown in Fig. 15. For the SCT records, interstory drifts in some stories reached values that are commonly associated with structural damage. Bending moments in the beams at column faces exceeded resisting values.
