Case Study of the Performance of Prestressed Concrete Buildings During the 1985 Mexico Earthquake

The overall effects of the 1985 Mexico earthquake on buildings are summarized, with specific consideration of the performance of prestressed concrete buildings. Then, for five typical prestressed concrete buildings, results of analyses of the dynamic response, with due consideration of the soil-structure interaction, are presented. In general, the computed response of the buildings under the effect of a ground motion simulating the 1985 earthquake, corresponded reasonably well with their observed performance. Nevertheless, in some cases the analyses indicated that the buildings should have experienced a greater nonlinear behavior than the ones perceived from their level of damage. Some reasons for these differences are discussed. Recommendations on earthquake-resistant design of prestressed concrete buildings are given. The importance of providing lateral stiffness by shear walls or bracing, and of achieving ductility and continuity through mild steel reinforcement, is emphasized.

ASSESSMENT OF EARTHQUAKE DAMAGE

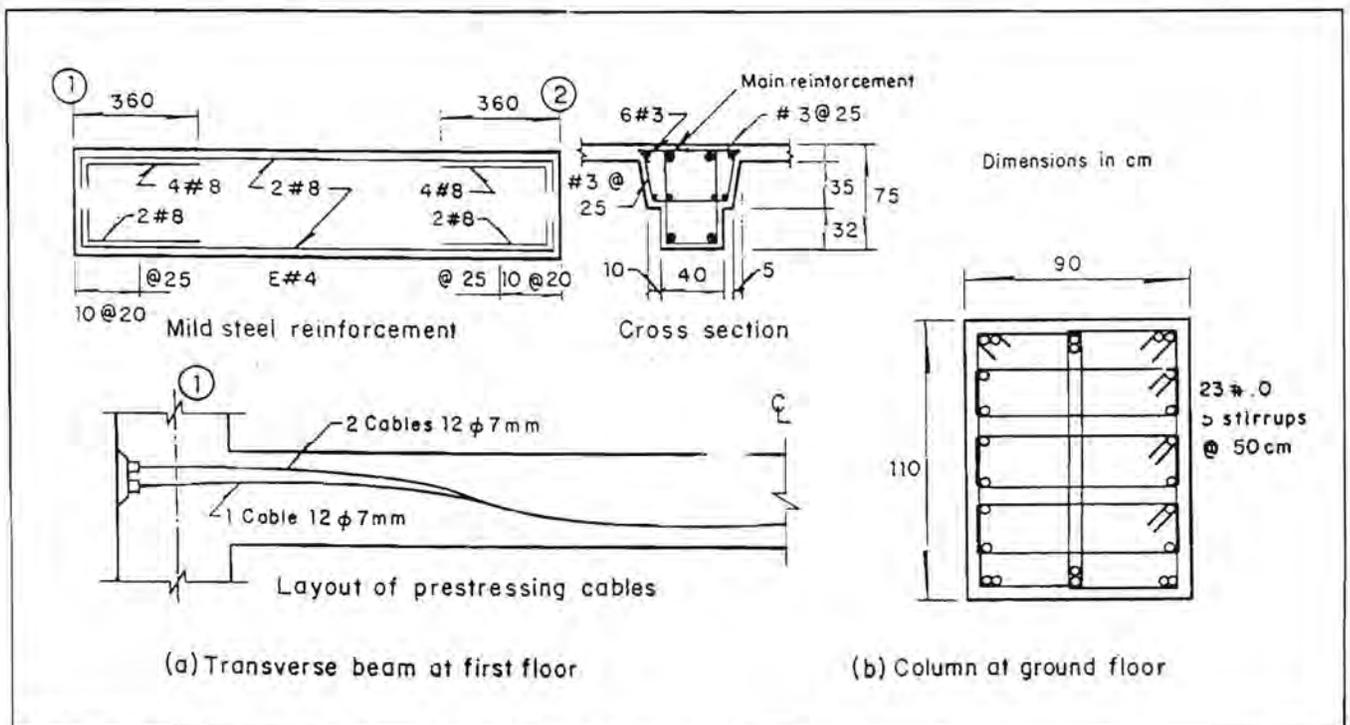
Fig. 8. Reinforcement details of structural members of the QRO Building.

An inspection of the building after the earthquake revealed extensive cracking in the masonry walls around the elevator shaft and distortion and falling of some ceiling panels. No

cracks were found in the main structural members. The building showed a significant tilting in its short direction (corresponding to about 2 percent of the building height).

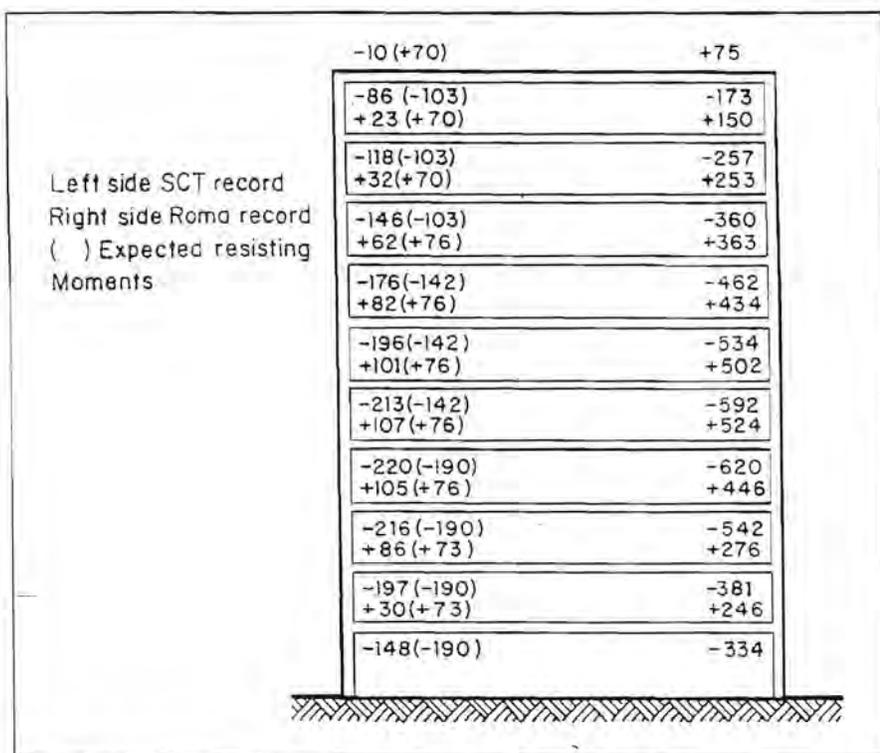
Fig. 11. Bending moments (ton-m) at beam end of the QRO Building.

From the analytical results, it can be observed, firstly, that the factored ROMA motion produced a response exceeding that of the SCT motion by a factor of approximately 3. The difference is explained by the observation of the response spectra of the two records. For a period of 1.3 seconds, corresponding to the fundamental period of the QRO Building, the ratio of the spectral ordinates of the two records is 3.7. The fact that the ratio of

the responses is similar to the ratio of spectral ordinates means that the structure responded essentially in the first vibration mode.

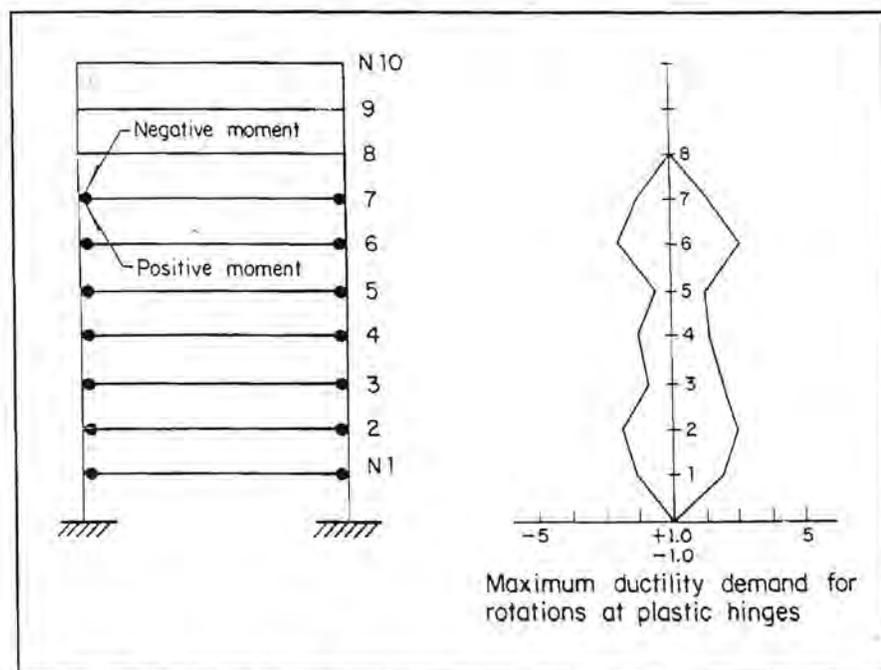
Fig. 12. Distribution of plastic hinges and maximum ductility demand for the SCT accelerogram in the QRO Building.

The results of the nonlinear analysis for the SCT record indicated the formation of plastic hinges for positive and negative moments, as shown in Fig. 12, with a maximum ductility demand of 3. Under the effect of the factored ROMA record, the plastification was more widespread and the ductility demand much larger.

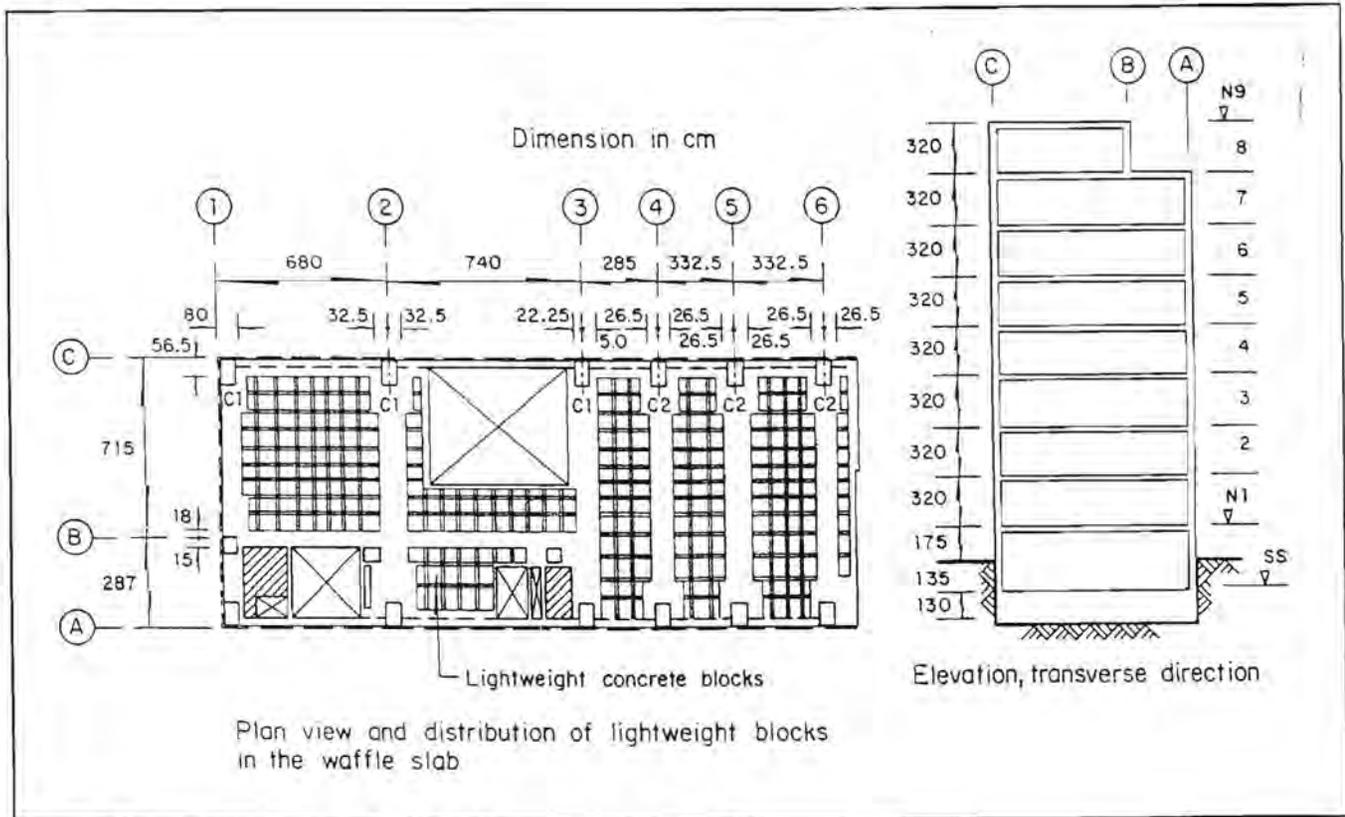
Fig. 13. Plan and elevation of the TAM Building.

This eight-story office building is located at the boundary of the lake bed area, where the depth of the soft clay deposits is about two-thirds of that at the QRO Building. In 1985, the damage in the area was moderate, indicating that the amplitude of the shaking was significantly less than that in the most damaged zone. The building has a cast-in-place concrete waffle slab supported by reinforced concrete columns.

The ribs of the waffle slab on the column lines are post-tensioned. Mild steel reinforcement in the ribs is very light, particularly for positive moments. Additional mild steel reinforcement is located at the solid zones
